**Structural Assessment Report  
Crouse House Stabilization**

**January 2016**

Barton & Loguidice, D.P.C.  
10 Airline Drive  
Albany, New York 12205

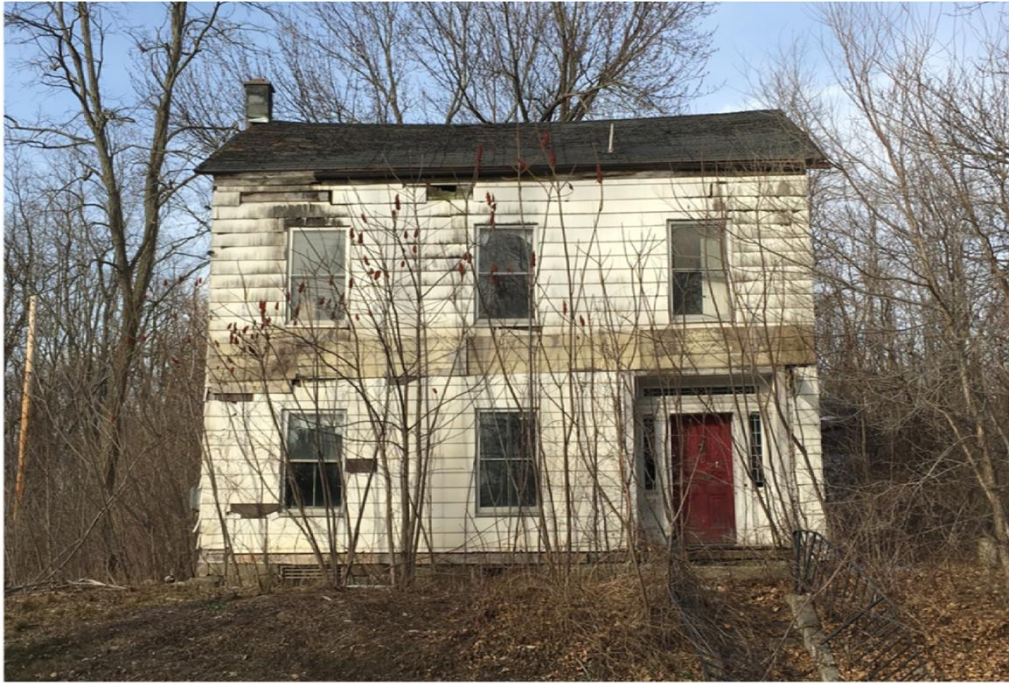
**PHOTO VIEW: 1 - South Wall Exterior Elevation - Frontage on State Route 146**

**COMMENTS:** Rot and water damage around windows, eave and at roof level.  
Structure is not properly secured at doorway and windows.

In advance of any shoring and/or reconstruction work we recommend that the Village Board take the appropriate action to secure the building at all doorways and windows preventing access by minors under 18 years of age, as well as vagrants and other trespassers.

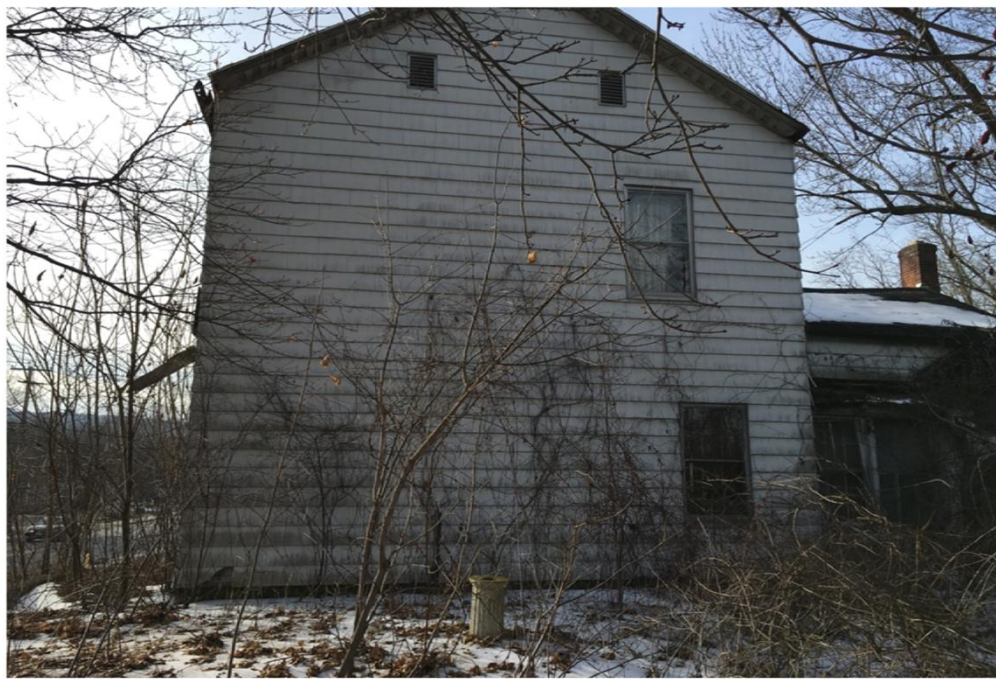
**PHOTO VIEW: 2 - East Wall Exterior Elevation**

**COMMENTS:** Rot and water damage at roof line.  
Structure is not properly secured at windows.

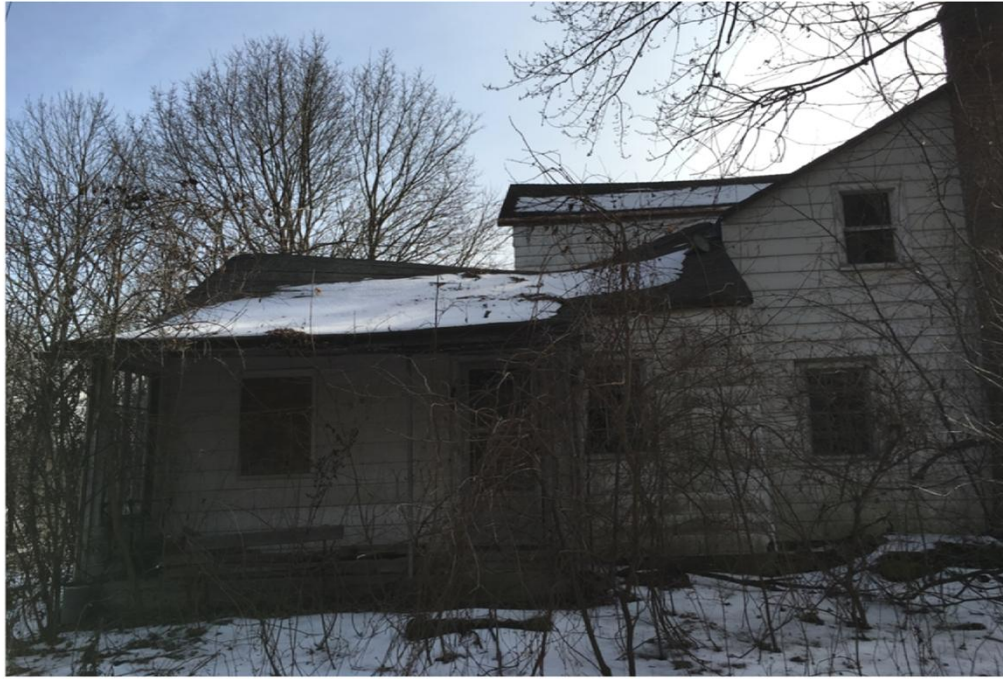
**PHOTO VIEW: 3 - North Wall Exterior Elevation**

**COMMENTS:** Proch roof sagging and near collapse, water damage and rot at roof level.  
Structure is not properly secured at doorway and windows.

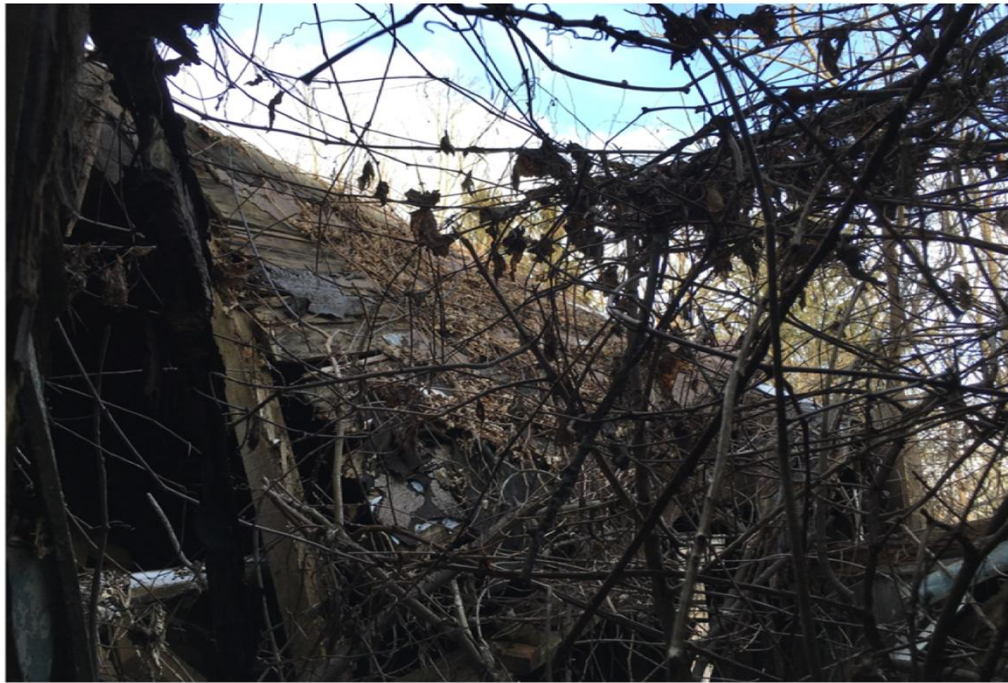
**PHOTO VIEW: 4 - Collapsed Structure - Potting Shed and Summer Kitchen**

The primary residence building is generally in fair to poor condition. This is attributed to the open areas and roof leaks allowing water to infiltrate the building causing damage to the structure and finishes, including extensive rot of structural elements. The attached porch, summer kitchen EII, laundry, hallway, and potting shed are partially to completely collapsed (**see attached photographs #3 and #4**). We did not access these areas to perform a detailed inspection of the structure as it is unsafe.

**COMMENTS:** Collapsed Framing and Roof.

The Village had previously requested bids from contractors to completely demolish the collapsed portions to 12-inches below finish grade, remove from the site and backfill the collapsed summer kitchen Ell, porch, hall, laundry, and potting shed. The repair scope also included securing, replacing and/or reinforcing rotted and deteriorated structural members in the kitchen ceiling of the primary residence and installing a new metal roofing system (29 gauge or heavier, pre-finished roofing panels, vented metal ridge and eave trim, metal flashing at all penetrations). Reinforcing existing structural members would involve "sistering" new rafters to existing and establishing new bearing at framing supports. The re-built roof would match the plane of the adjacent roof to the extent possible. Existing foundations, frost walls, and sill plates would need to be repaired as part of the structural stabilization work.

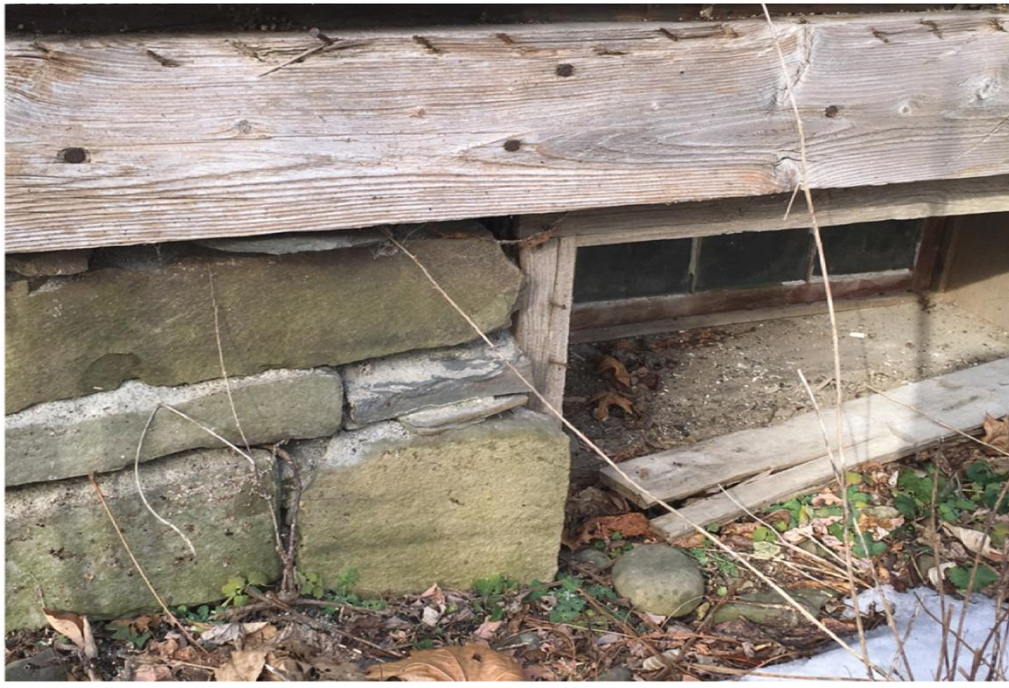
**PHOTO VIEW: 5 - Foundation Wall**

The exposed stone foundation wall has shifted and settled. The base of the south wall has bowed outward as the wood sill plate has rotted and is providing little to no support (**see attached photographs #5 and #6**). The majority of the mortar joints are loose however the walls below the sill plate are generally plumb and appear to be functioning as intended.

**COMMENTS:** Separation in foundation stones, rot and water damage to sill plate.

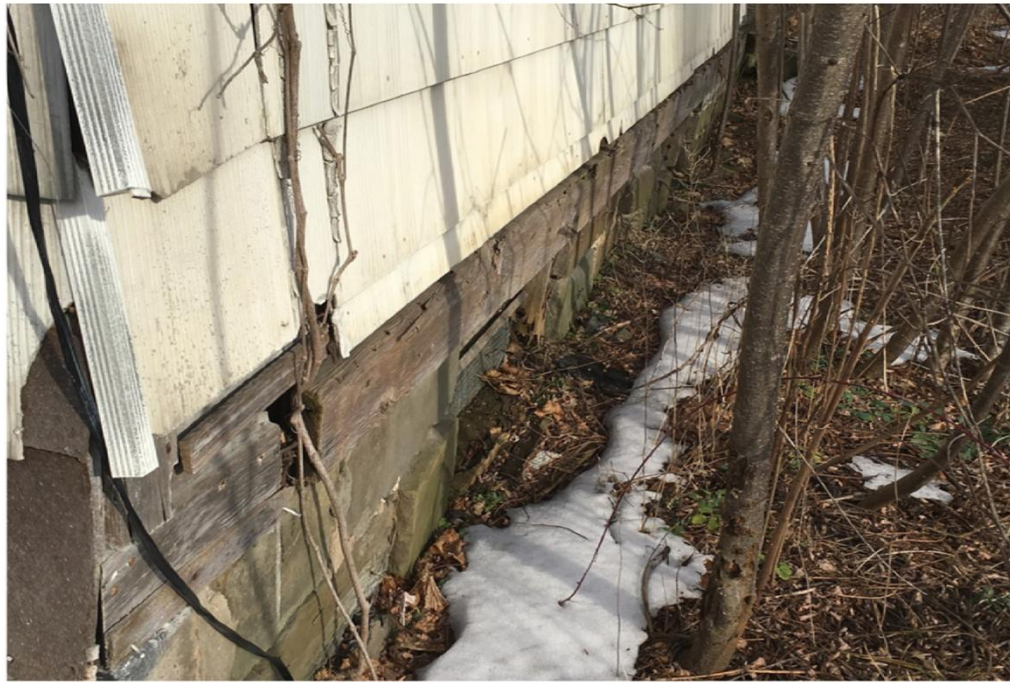
**PHOTO VIEW: 6 - Foundation Wall**

**COMMENTS:** Bowing outward at base of wall, rot and water damage to wood sill plate.

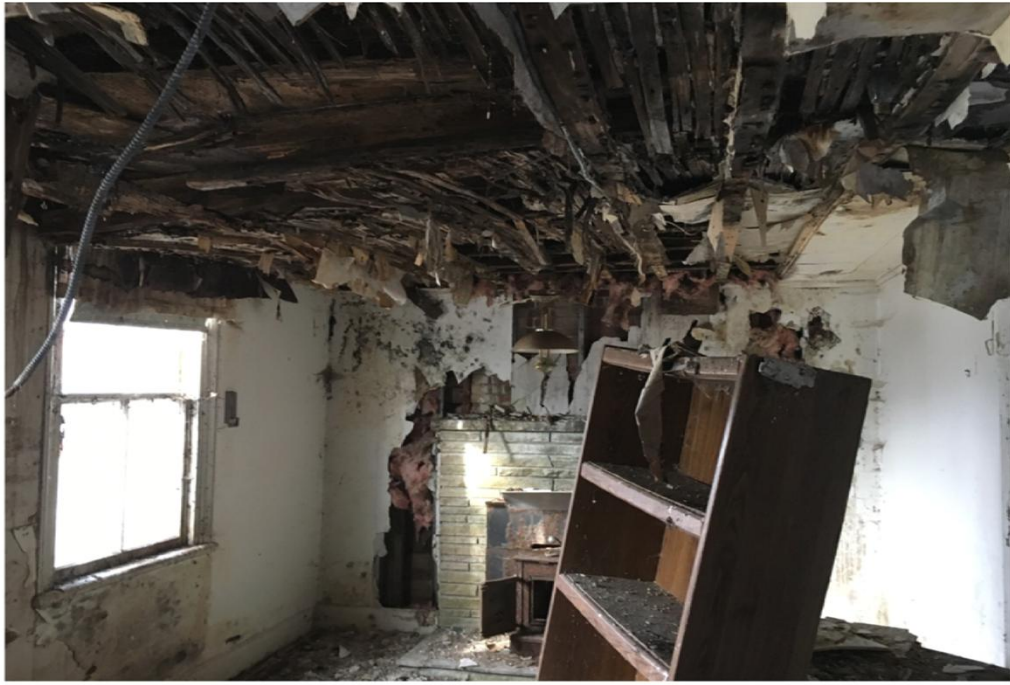
**PHOTO VIEW: 7 - Kitchen Area**

The floors are covered with a combination of wood flooring and tile. The kitchen ceiling is severely deteriorated and rotted due to excessive water damage (**see attached photographs #7 and #8**). With this condition the ceiling/second floor of the storage rooms is structurally unsound and near collapse. Wall framing above the summer kitchen has deteriorated and collapsed leaving areas of the second floor open to the outside elements (**see attached photograph #9**). Second level floor areas in the primary residence are sagging due to age and possible rot below the floor (**see attached photograph #10**).

**COMMENTS:** Water damage and rot to second floor framing - near collapse.

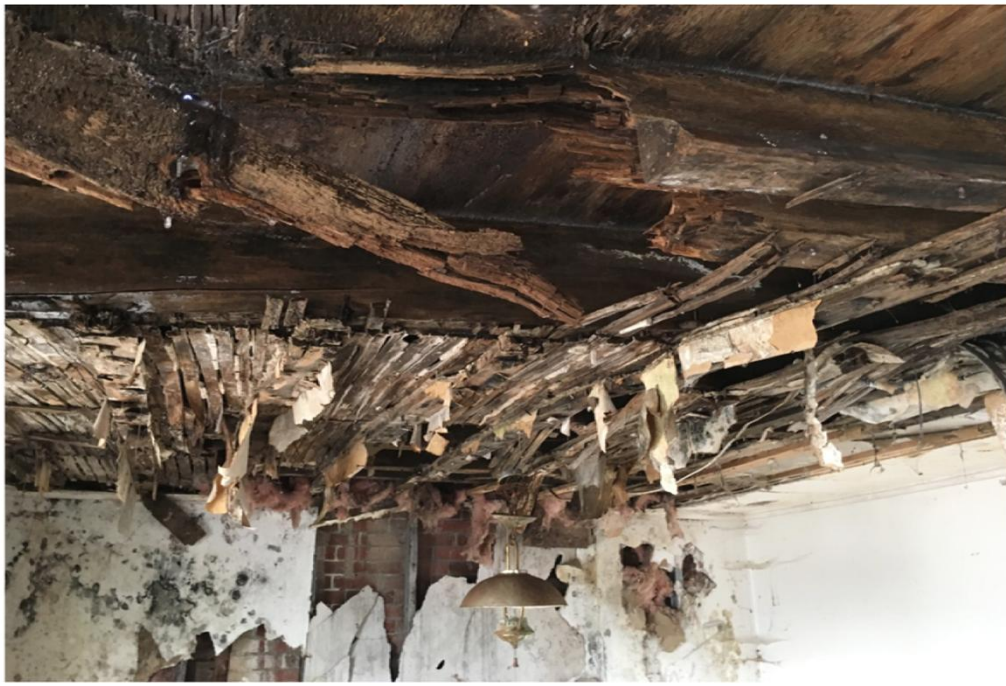
**PHOTO VIEW: 8 - Kitchen Area**

**COMMENTS:** Water damage and rot to second floor support framing.

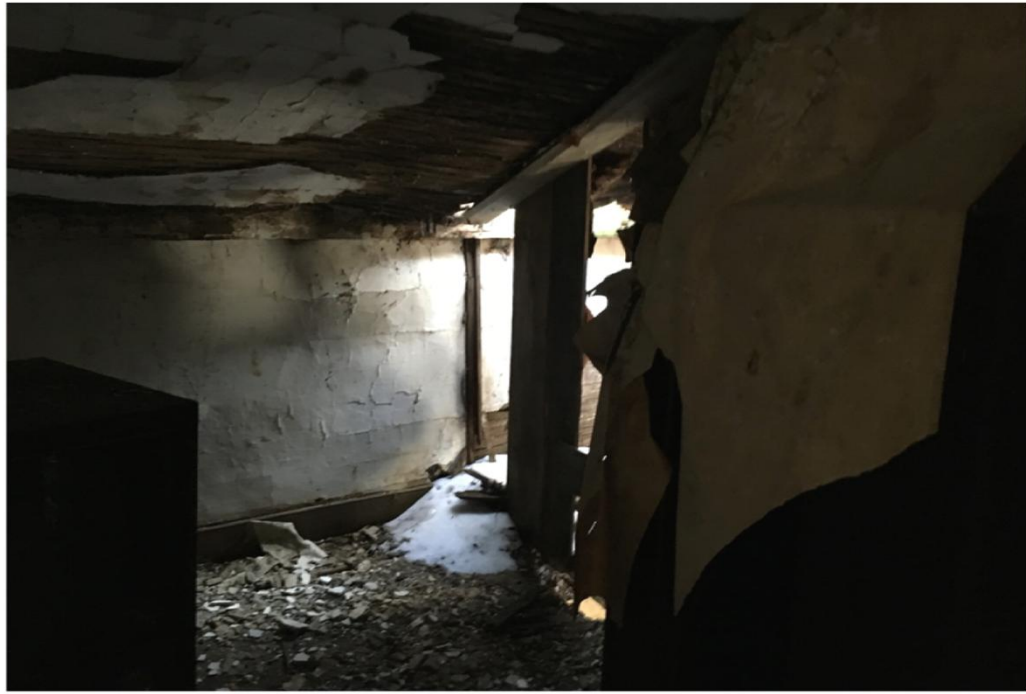
PHOTO VIEW: 9 - Second Floor Above Summer Kitchen

COMMENTS: Exterior wall - open to outside elements and near collapse.

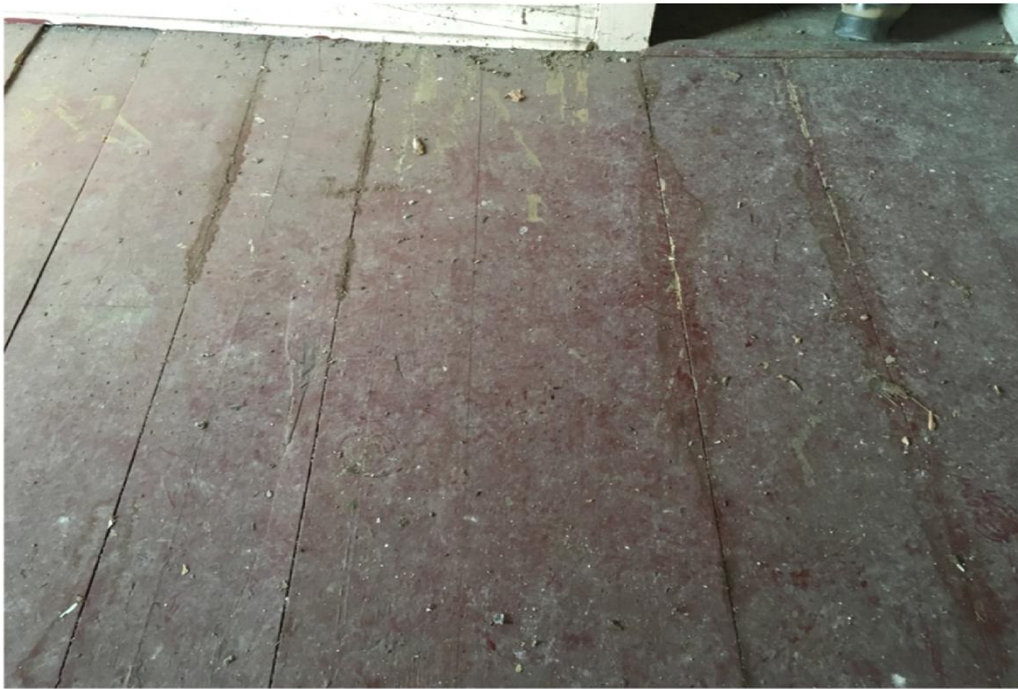
PHOTO VIEW: 10 - Second Floor

COMMENTS: Sagging floor boards, poor support.

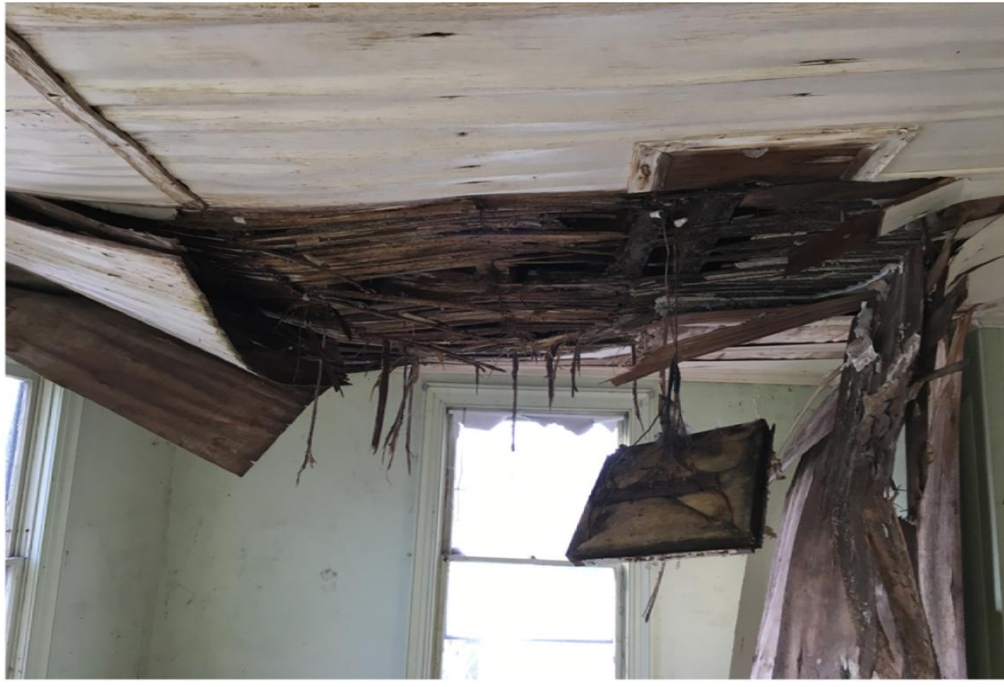
**PHOTO VIEW: 11 - Second Floor Bedroom**

Active roof leaks were noted; however, there is limited evidence of large scale leaks in the attic area. Areas of the second floor bedroom ceiling show significant signs of water damage and rot (**see attached photographs #11 and #12**).

**COMMENTS:** Excessive water damage and rot - near collapse.

In addition, we recommend a water damaged area of the second floor bedroom ceiling be repaired. Prior to installing the new metal roofing system, the existing asbestos containing material (ACM) roofing material needs to be removed by a NYSDOL licensed asbestos abatement contractor. The opinion of probable construction cost for this work is \$52,900. Generally the work includes asbestos survey, asbestos abatement and air monitoring, structural inspection, additional structural reinforcement, re-formatting existing bid documents for public bids and the low quote received by the Village. The opinion of probable cost does not include structural engineering necessary for reinforcing the primary residence.

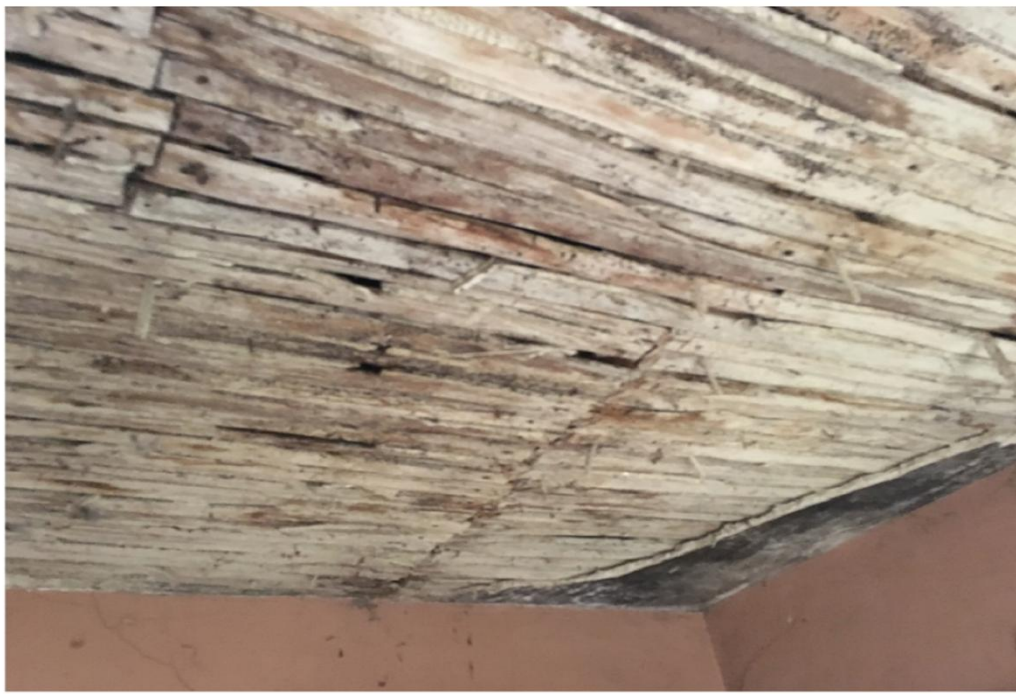
**PHOTO VIEW: 12 - Second Floor Bedroom**

**COMMENTS:** Sagging lath board ceiling.

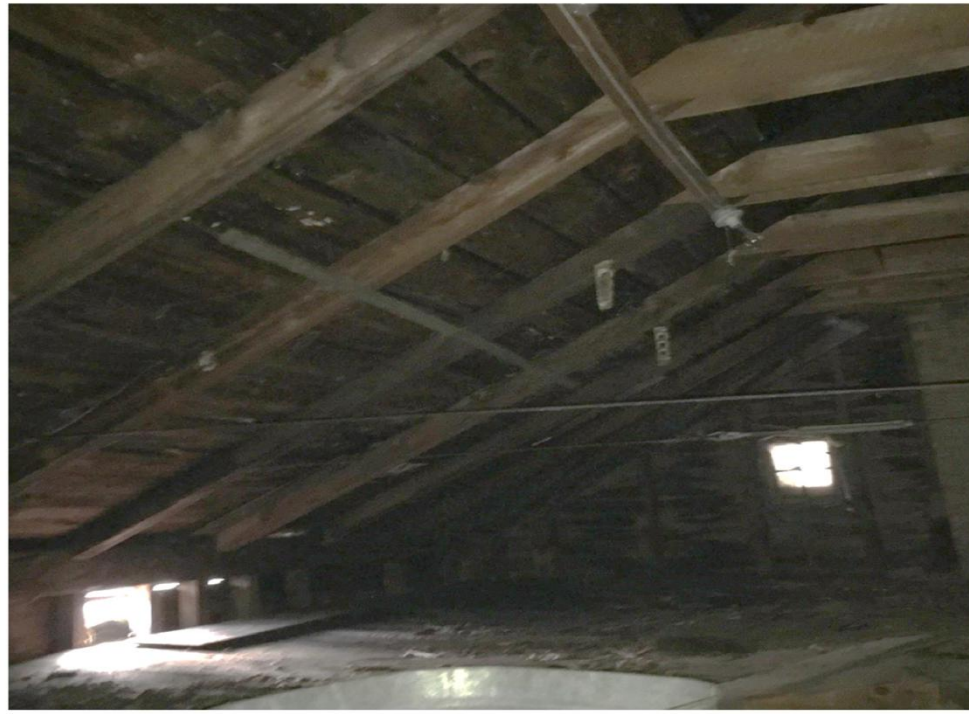
PHOTO VIEW: 13 - Attic Area - Roof Rafters

COMMENTS: Tie rods, roof leaks - water damag to floor.
