*RUSS REEVES, CEng., P.E. CIVIL-STRUCTURAL ENGINEERS NYS Lic. # 063979

July 27, 2022

Re: Emergency Structural Condition Assessment Central Warehouse Building 143 Montgomery Street, Albany, New York.

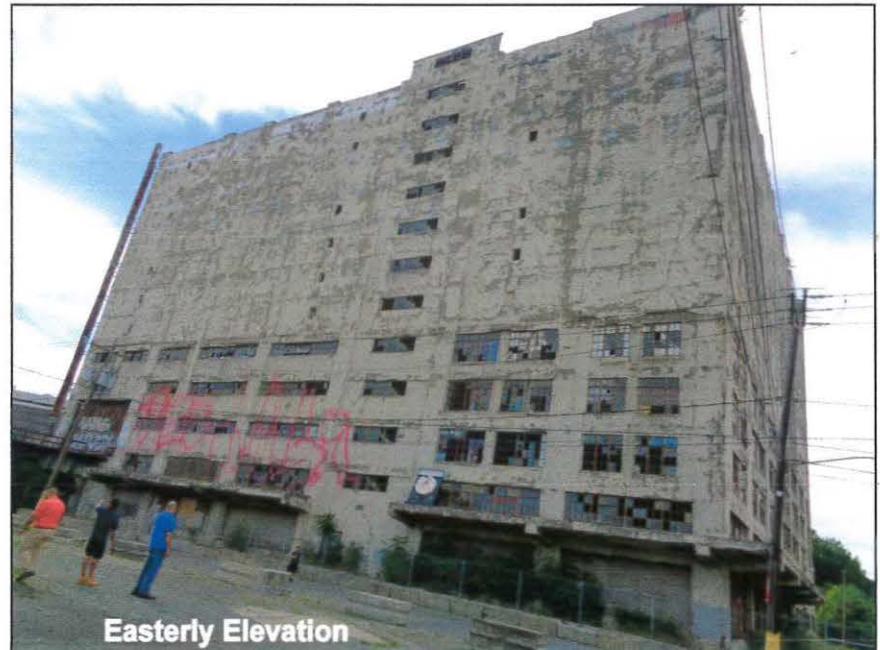
Photograph 1

Photographs 1 and 2 show the Easterly and Northerly elevation views of the building respectively. The building has been exposed to the elements for an estimated 25 year duration. On Friday October 23, 2010 the structure had been the subject of a multiple alarm fire that fully

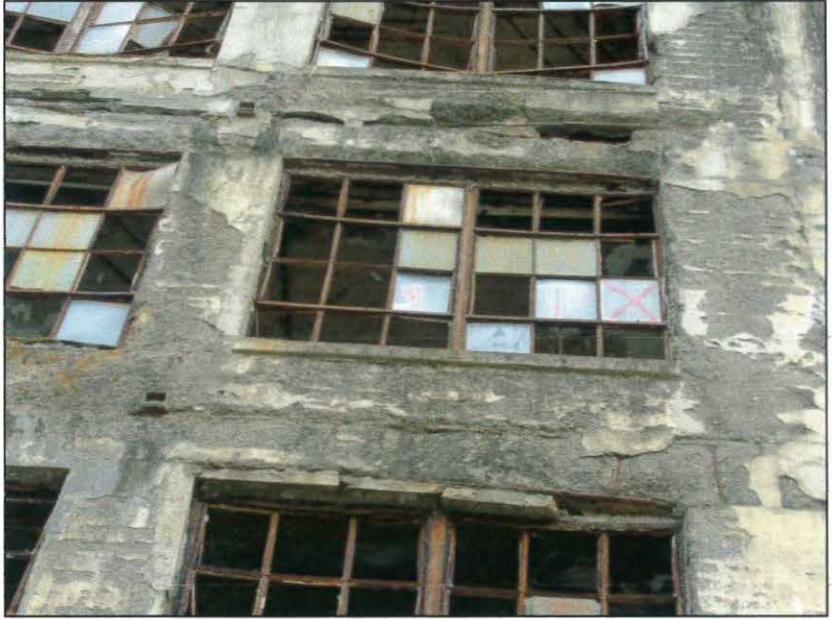
Photograph 3 (Northerly Elevation) General Description of the Building:

Photograph 3 shows a typical view along the Northwesterly portion of the building at the 4th and 5th floor level. In this instance, there are spalled masonry spandrel beams that exhibit gross deterioration with portions of the concrete on the verge of failure. This can be more specifically seen in Photograph 3. During the course of the evaluation, we found substantial fracture cracking through the upper Northeasterly corner pilaster. Over the years, water has saturated existing fractures and fissures within the concrete wall section and has frozen and expanded thus dislocating sections of concrete from reinforcing steel and has degraded the concrete to the point where some of the concrete has ruptured thus creating a major public safety hazard. This condition is typical at all four corners of the building.

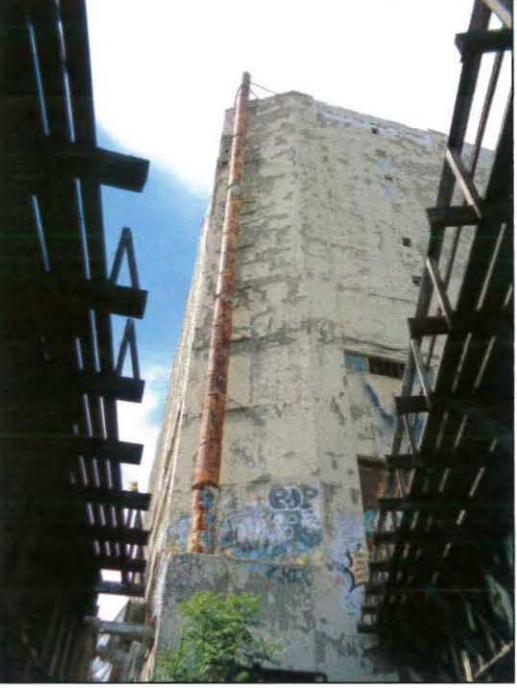
Photograph 5 (Southeasterly Corner)

Photographs 5 and 6 show the Southeasterly corner of the structure and a close-up view of a failed concrete wall section at this location respectively. It shall be noted that a further collapse of the fascia concrete wall at this location is considered imminent at this time and will likely

adversely affect the Amtrak rail tracks and locomotive safety. It is recommended that the owner contact Amtrak as soon as practicable and make them aware of this hazardous condition. Corrective action will need to be taken to avoid compromising public safety. A recommendation on this will be made later in this report.

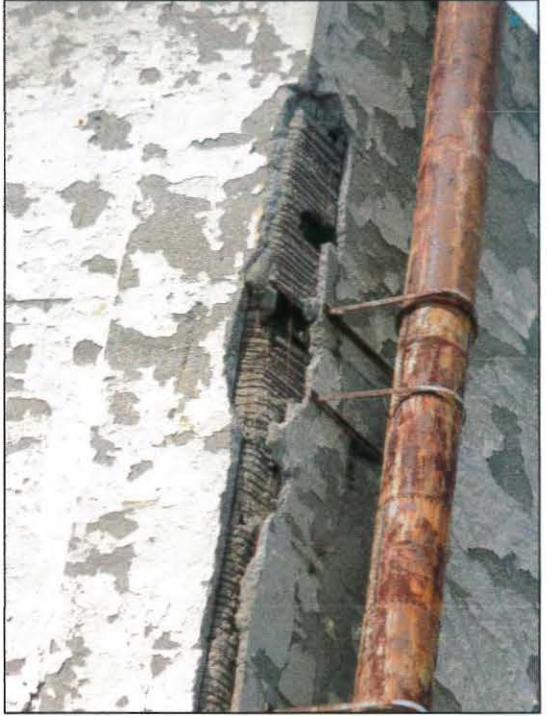
Photograph 6

depicted by an X delineation. This condition is typical about each corner section around the perimeter of the building. These fracture cracks have also lead to the localized collapse of a portion of fascia wall along the Southeasterly side of the structure (refer to Photograph 6).

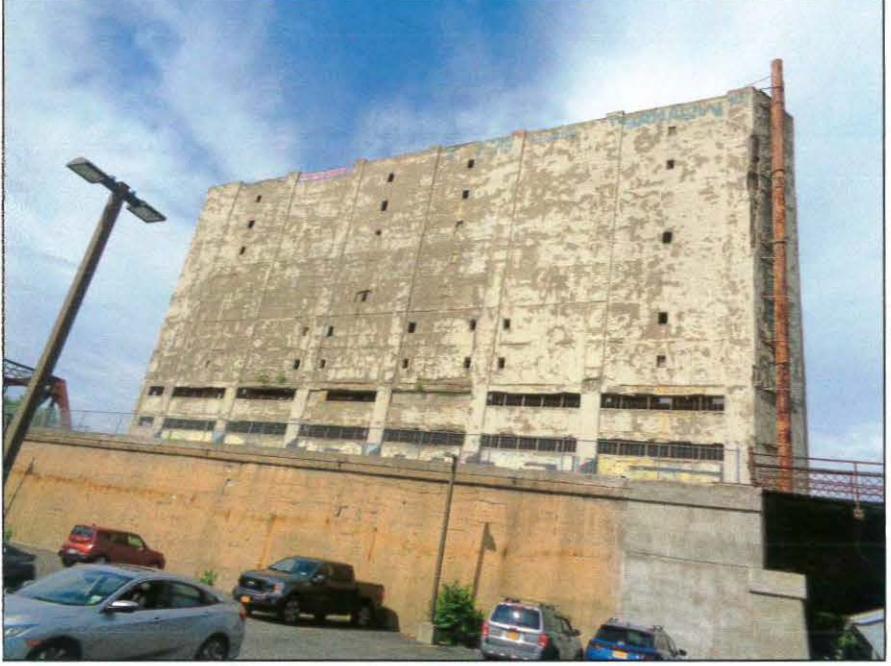
Photograph 7 (Southerly Elevation)

Photograph 7 shows the Southerly elevation view of the building. It is noted that fracture cracks have occurred in the entire Southerly exterior fascia wall between the fascia columns / pilasters at every floor location. This can be more specifically seen in Photograph 8.

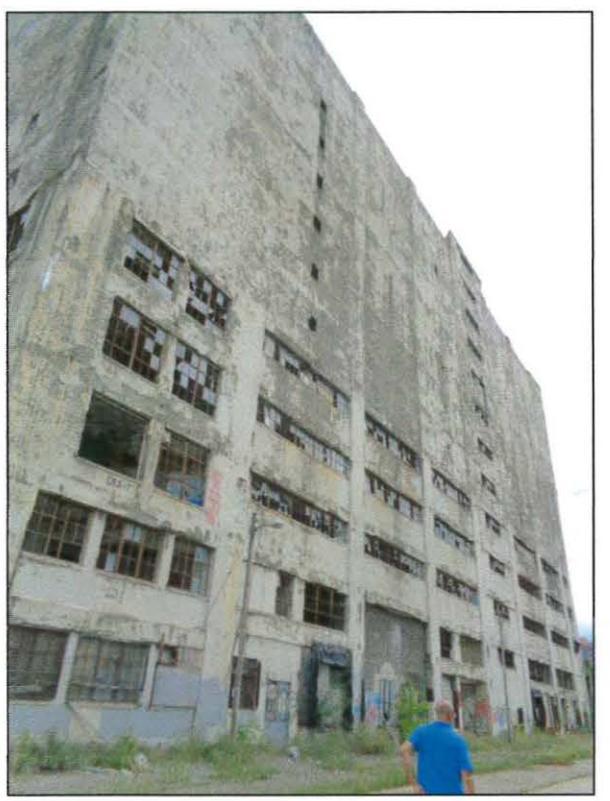
Photograph 9 (Westerly Elevation)

Photograph 9 shows the Westerly elevation view of the building. The Westerly stair tower can be seen in the foreground of the photograph (the stair tower extends above the roof line). Extensive deterioration and fracture cracking can be seen through the Northwesterly and Southwesterly fascia columns / pilasters (refer to Photographs 10 and 11 repsectively) and is

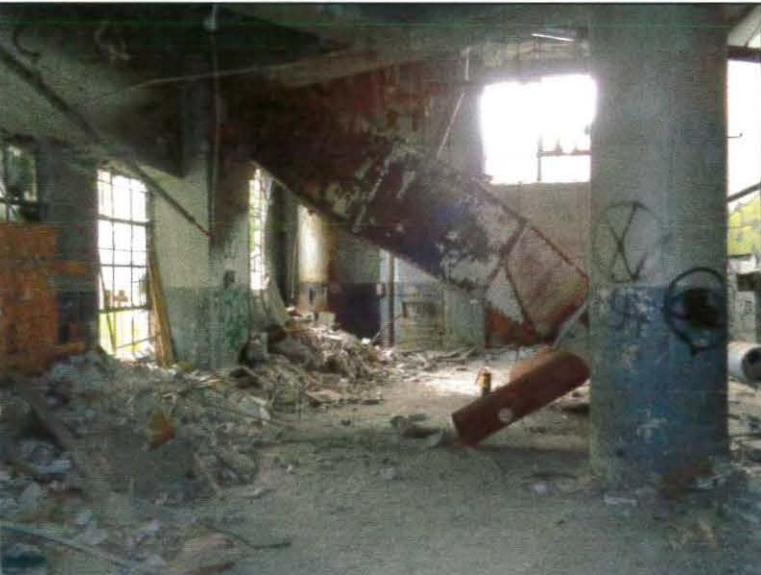
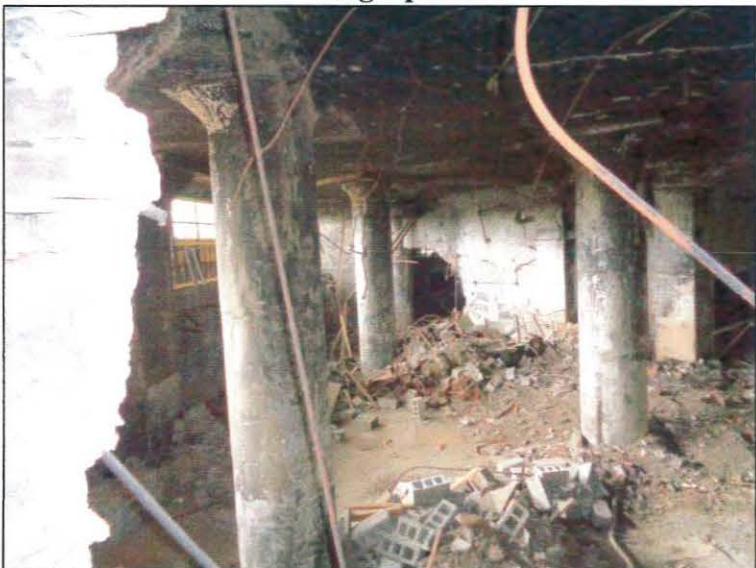
There is a substantial amount of debris that can be seen throughout the building at each floor level. A typical view of the debris and overhead hazards is shown in Photographs 13 and 14. These photographs have been taken at the first floor level. Loose masonry, piping and

equipment should be safely removed so as to avoid a hazardous overhead condition for Fire Department and Code Enforcement personnel who are entering the structure in the event of an emergency or for an inspection. The owner shall be made aware of this o that corrective action can be taken to insure OSHA and DOL compliance.

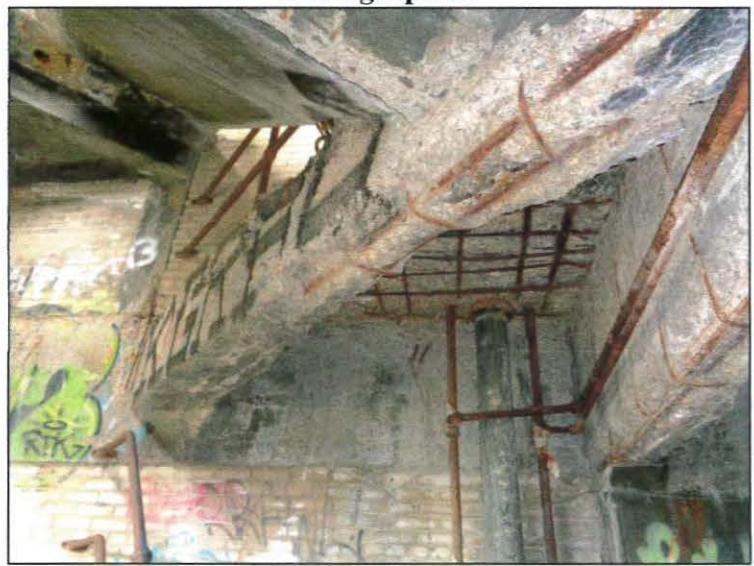
Photograph 16

Extreme caution shall be exercised when entering the building and specifically the stair towers. Reinforced concrete beam sections and staircases exhibit excessive deterioration, corrosion, section loss and fracture cracking as can be seen in Photographs 16 and 17. Further spalling of concrete is likely. A partial collapse of some of the reinforced concrete beam sections and staircases are considered imminent as can be seen in Photograph 18. This condition is prominent at the upper floor levels.

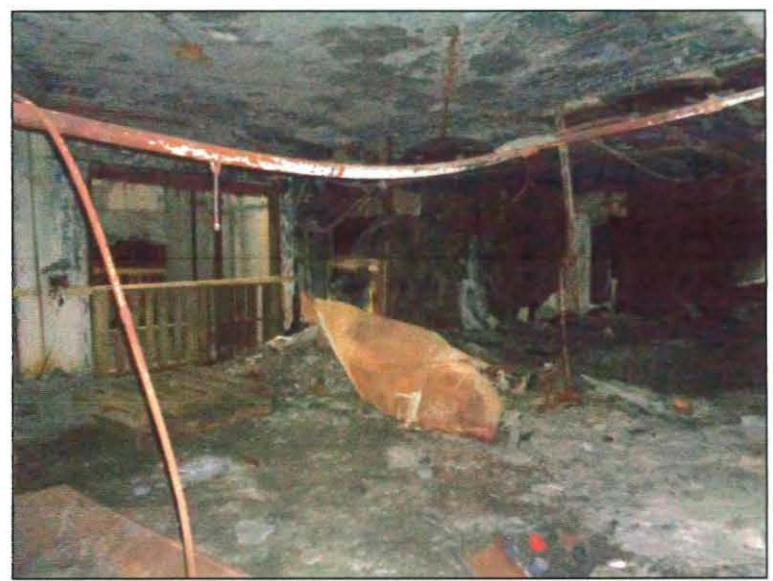
Photograph 19

In addition, there are extensive debris piles at various upper levels of the building as a result of the fire. A typical view of this condition can be seen in Photograph 19. It is recommended that no personnel access floor levels where debris piles cover the floor areas due to the possible presence of floor penetrations that have not been properly covered but are concealed by the presence of debris piles.

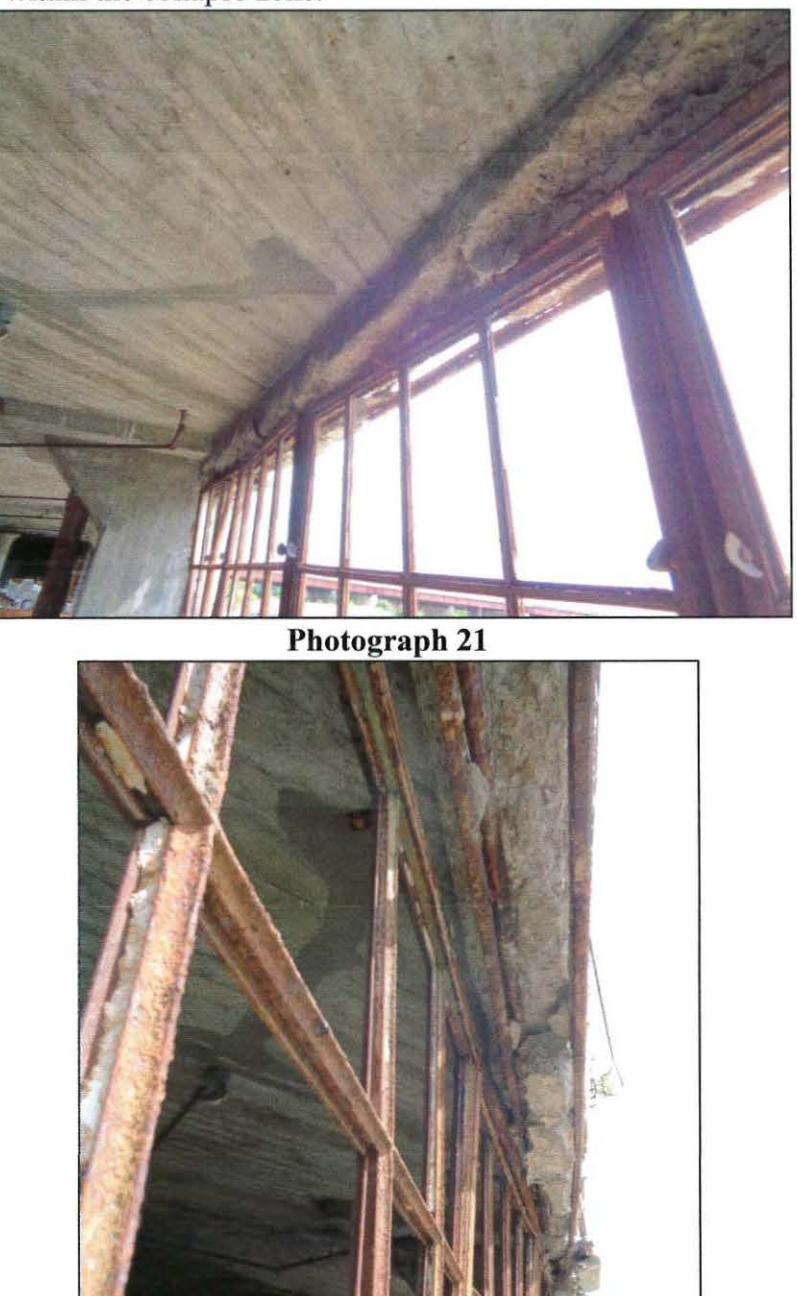
Photograph 22

Photographs 21 and 22 show typical views of the interior and exterior spandrel beam sections above the larger window openings along the Southerly side of the building. The deterioratd nature of the concrete and spalling is typical at the second, third, fourth and fifth levels of the building. A localized collapse of these deteriorated spandrel beam sections is also considered imminent at this time. Deteriorated upper pilaster fascia columns and fascia wall sections is problematic along the Southerly side of the building. The Amtrak railroad tracks lie within the collapse zone of the building. This condition is specifically a concern from the upper floor levels where the vertical height at the failing concrete exceeds the horizontal distance from the Southerly face of the building to the centerline of the rail tracks, thus making the dual track system lie entirely within the collapse zone.

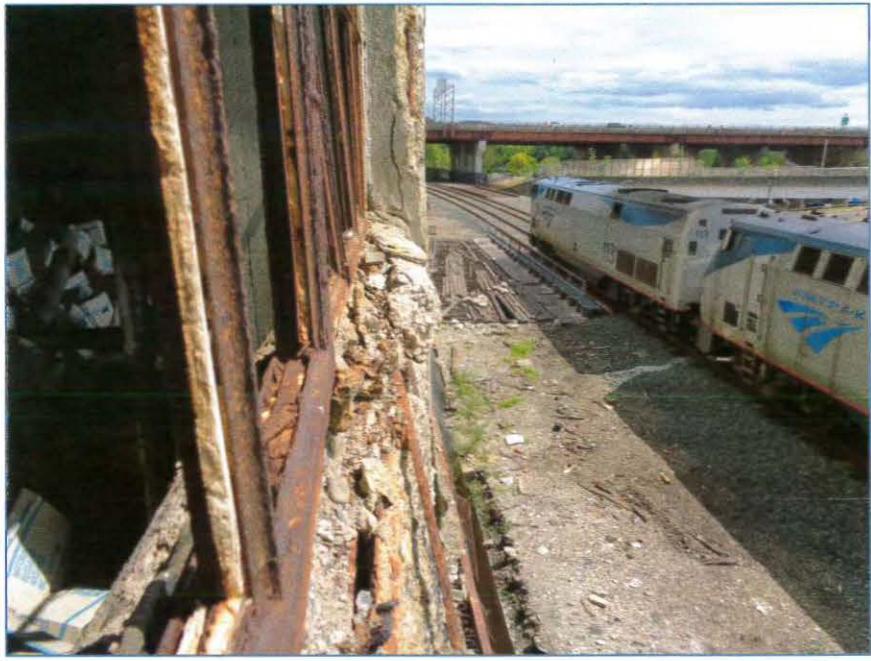
Photograph 23 shows deterioration and spalling of the top portion of the Southerly spandrel beam at the fifth floor level and fracture cracks through the concrete pilaster fascia column. Failure in portions of these components are considered imminent.

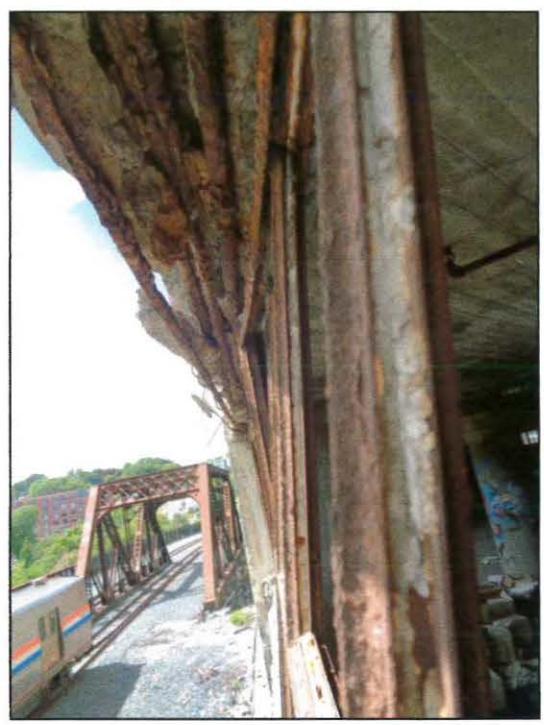
Photograph 25 shows the upper spandrel beam and a portion of the exterior wall section deflecting outward and on the verge of collapse. The issue of the deteriorated exterior masonry concrete will need to be addressed as soon as practicable due to its implication to public safety and the integrity of the Amtrak system along the Southerly side of the building. It is recommended that the Southerly exterior fascia wall be anchored into the interior reinforced

floor system at every floor level using ³/₄" diameter A-304 stainless steel threaded rod and 12" x 12" x 1/4" A-36 steel plates that will restrain the exterior fascia wall. The stainless steel threaded rods shall extend through the fascia wall, through the interior cavity and through the interior wall section and be connected to a ³/₄" x 2" diameter Crosby Eyelet. A 7/16" diameter 6 x 19 class IWRC (Independent Wire Rope Core) cable with turn buckle shall be anchored into the reinforced concrete floor using a WT section with four 5/8" diameter A-304 stainless steel threaded rods having a 4" embedment into the existing concrete slab and epoxy grouted with Hilti Epoxy hit-re 500 V-3. The spacing and location of each wall anchorage will be established as part of the final design for the exterior wall stabilization. Please note that all cable connections will be made with three A-304 stainless steel cable clamps per connection. All steel plate shall be shop painted using DTM Alkyd Enamel paint. Once the exterior wall has been stabilized and anchored into the floor system at every floor level, braced scaffolding can be erected that will afford the safe removal of the deteriorated and failing reinforced concrete spandrel beams. Deteriorated and failing steel window frames shall also be carefully removed so they do not collapse in this removal and stabilization process. The braced scaffolding will need to be laterally restrained into competent concrete at each floor level with the existing concrete floor slab being the primary means of restraint. The owner's engineer shall provide the necessary stabilization drawings, procedures and material specifications to the City of Albany for review and approval.

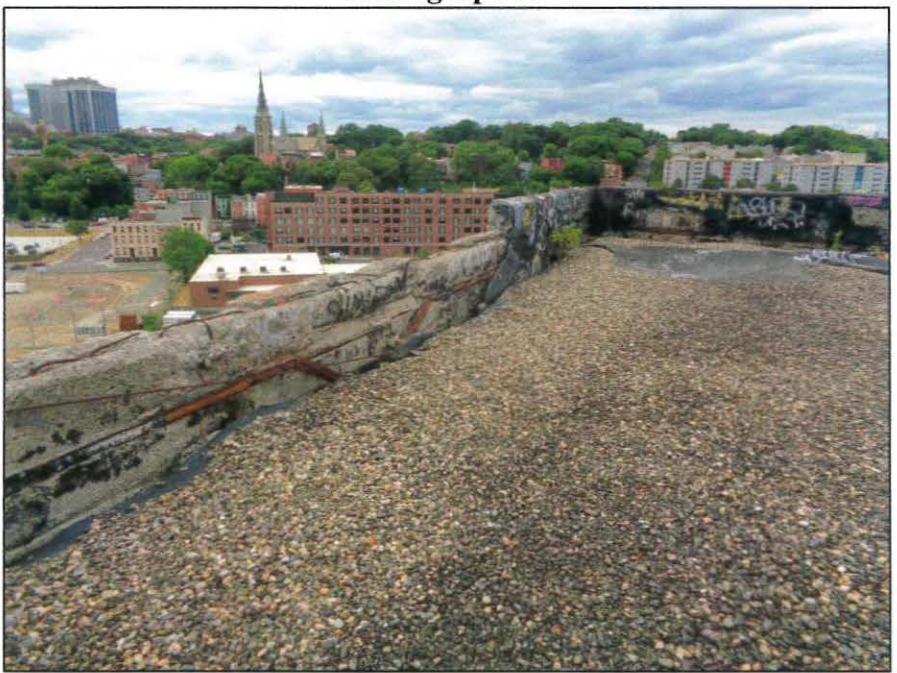
Lastly we accessed the roof area in which we found substantial deterioration and failure in the perimeter parapet wall and failure at the interface of the roof slab and the exterior fascial wall. Photograph 26 shows deterioration and failure at the Southerly parapet wall. This parapet wall is highly unstable. Movement in the parapet wall was detected while on- site. Heavy vibration and movement of the wall was noted especially when Amtrak trains passed the building. Photographs 27 and 28 show a typical view of the failed section of roof and deteriorated tie rods that connect the exterior wall section with the interior wall section. Photograph 29 shows the

roof failure along the majority of the length of the Southerly parapet wall. A localized collapse of portions of the parapet wall is considered imminent and will affect the Amtrak rail system which lies within the collapse zone of the parapet wall and Southerly exterior fascia wall.

The present condition of the building is considered a high hazard to the Amtrak facility and public safety. It is recommended that the owner be made aware of the structural deficiencies associated with the building so that implementation of a stabilization plan can occur as soon as practicable. The owner shall contact Amtrak to apprise them of the condition of this building as it relates to their track safety and shall obtain a permit from the City of Albany to implement a Professional Engineer designed remediation plan.

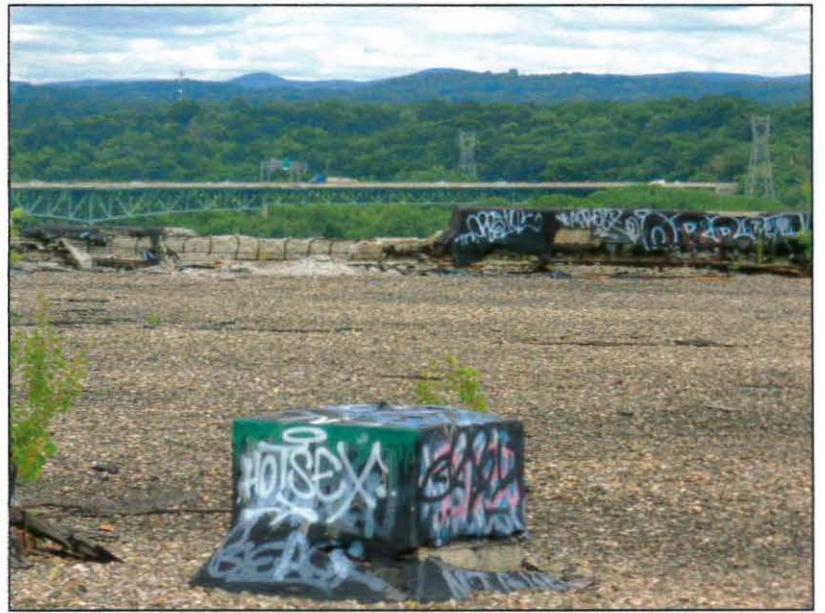
Photograph 30 shows a portion of the Southerly parapet wall that has already failed. Photograph 31 shows horizontal fractures through the parapet wall which is highly unstable and a collapse of this portion of the wall is considered imminent at this time. The remaining perimeter parapet wall shall be considered unstable due to the extent of deterioration observed in the parapet wall section.
