REFERENCE SLIDES

Written Notice to the Berne Superintendent of Highways & Town Clerk

Long term unprotected drop-offs & inadequate shoulder cross slopes are a public safety hazard

INFORMATION FOR ENGINEER'S RECOMMENDATIONS FOR:
HIGHWAY WORK ZONE PRACTICES IN CHIPS OVERLAY PROJECTS,
THE INTERPRETATION OF STANDARDS,
&
THE IDENTIFICATION AND EVALUATION OF
PROBLEMATIC LOCAL RURAL HIGHWAY SEGMENTS
IN CHIPS OVERLAY PROJECTS

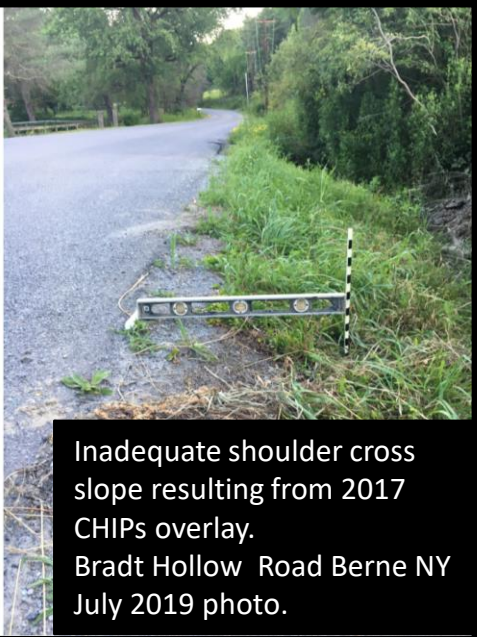
The other option is To ignore the issue and provide a dangerous cross slope at the shoulder. This cross-slope is not functional. It will likely destabilize vehicles and draw them off the highway to potentially roll over and/or strike fixed objects.

Inadequate shoulder cross slope resulting from 2017
CHIPS overlay.
Bratt Hollow Road Berne NY
July 2019 photo.

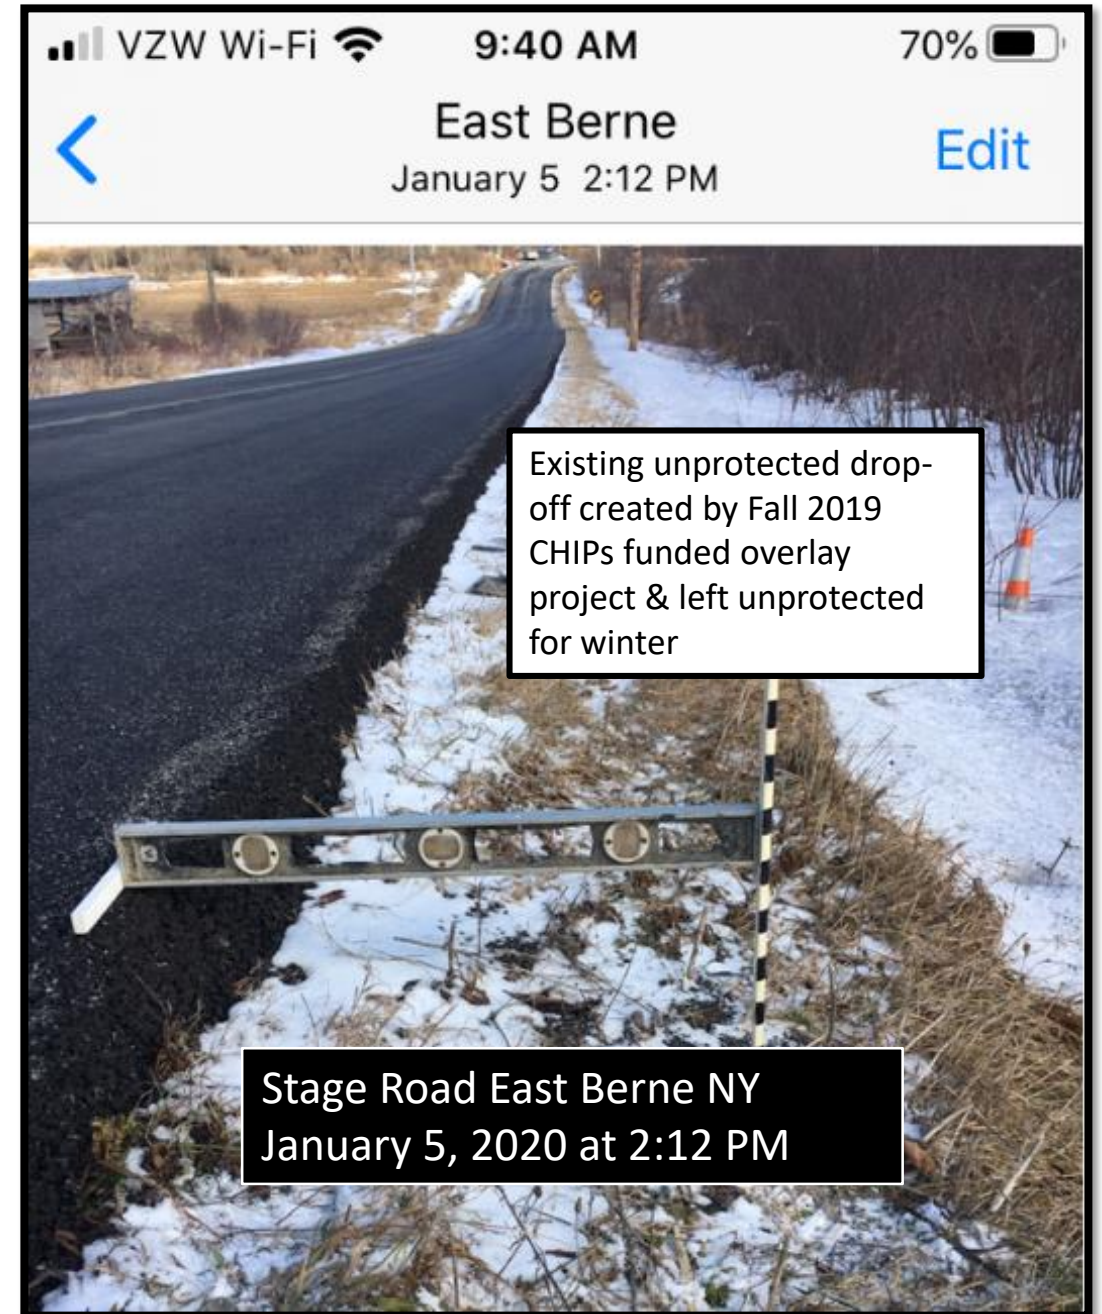
Stage Road East Berne NY
January 5, 2020 at 2:12 PM

Existing unprotected drop-off created by Fall 2019
CHIPs funded overlay
project & left unprotected
for winter

This is an excerpt from information to be provided to consultant Engineer for evaluation. It is well outside acceptable industry practice to leave unprotected drop-offs, particularly long term. Leaving them in winter conditions is just absurdly dangerous.

This situation should be evaluated by a professional Engineer, but based on my interpretation of Table 619-3 of the NYSDOT Standard specifications, our situation for Drop-off heights in the first column often exceeds 6 in and our drop off is clearly within 4 ft of the travel lane (see following slides). Our situation is reflected in the "2 -6 in" and "6-24 in" row. In the second column, at the 2-6 in row, white lines at the edge of the travel lanes reduces the number of drums or panels needed significantly. White lines improve safety in this situation by marking the location of the drop-off, but when leaving such drop-offs in winter, white lines are clearly not effective. The lines and the drop offs are not visible in snow. In the 3rd column, "yes" indicates this situation is considered a "shoulder closure". The 4th & 5th columns indicate the recommended frequency of drums or panels to channelize traffic. An engineer may consider 20 ft excessive given the situation, particularly if the shoulders are to be placed within a couple days. But as the photos indicate, Berne uses no drums or panels at all and leaves the unprotected drop offs for months and in winter conditions. The tubular markers and tall cones in columns 6 and 7 are not considered acceptable for this situation as indicated by the word "no" in those columns. Finally, column 8 indicates that the appropriate sign for our situation is "NO SHOULDER" because we are technically closing the shoulders. There is clearly no usable shoulder with these drop-offs.

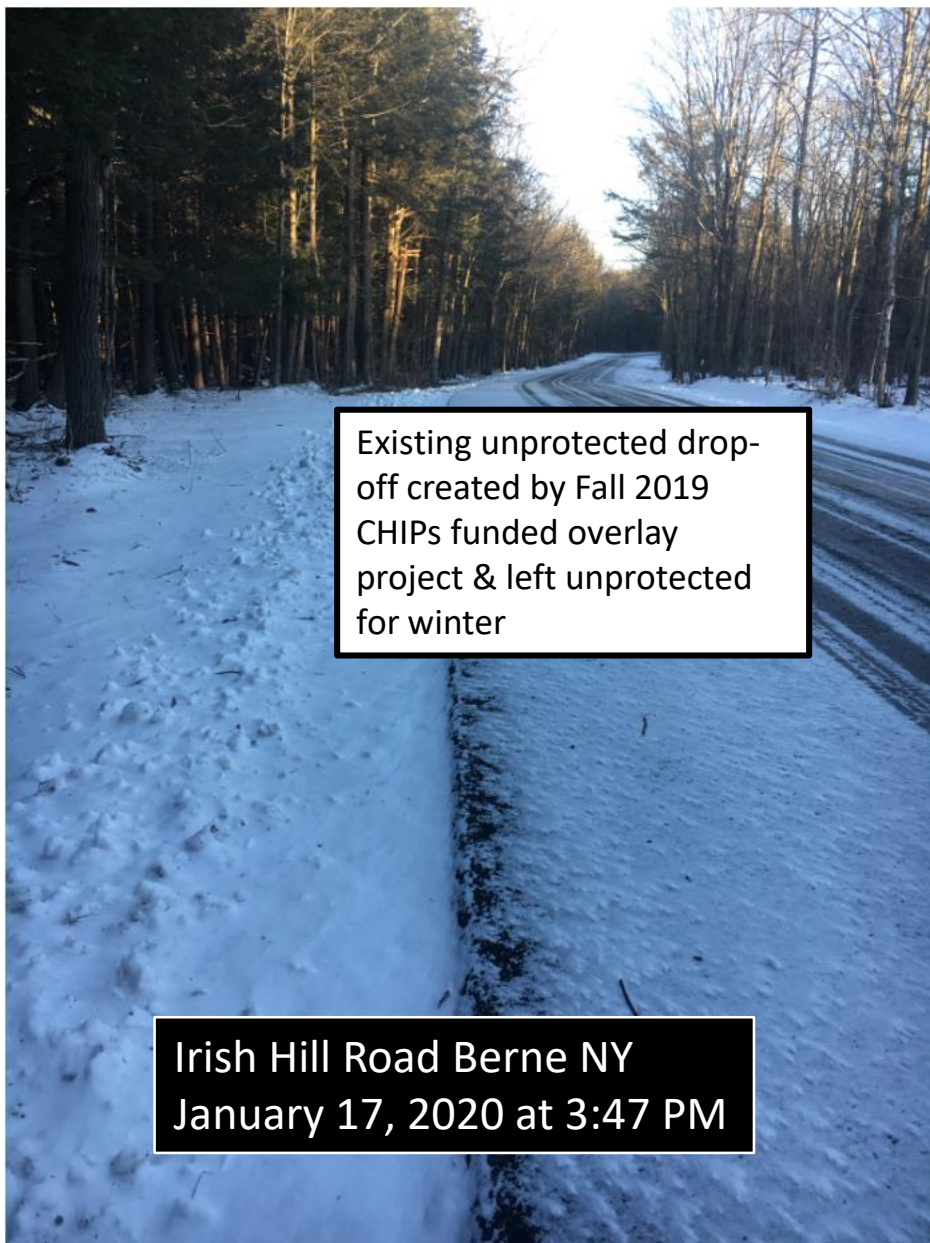
Irish Hill Road Berne NY
January 17, 2020 at 3:47 PM

Existing unprotected drop-off created by Fall 2019
CHIPs funded overlay
project & left unprotected
for winter

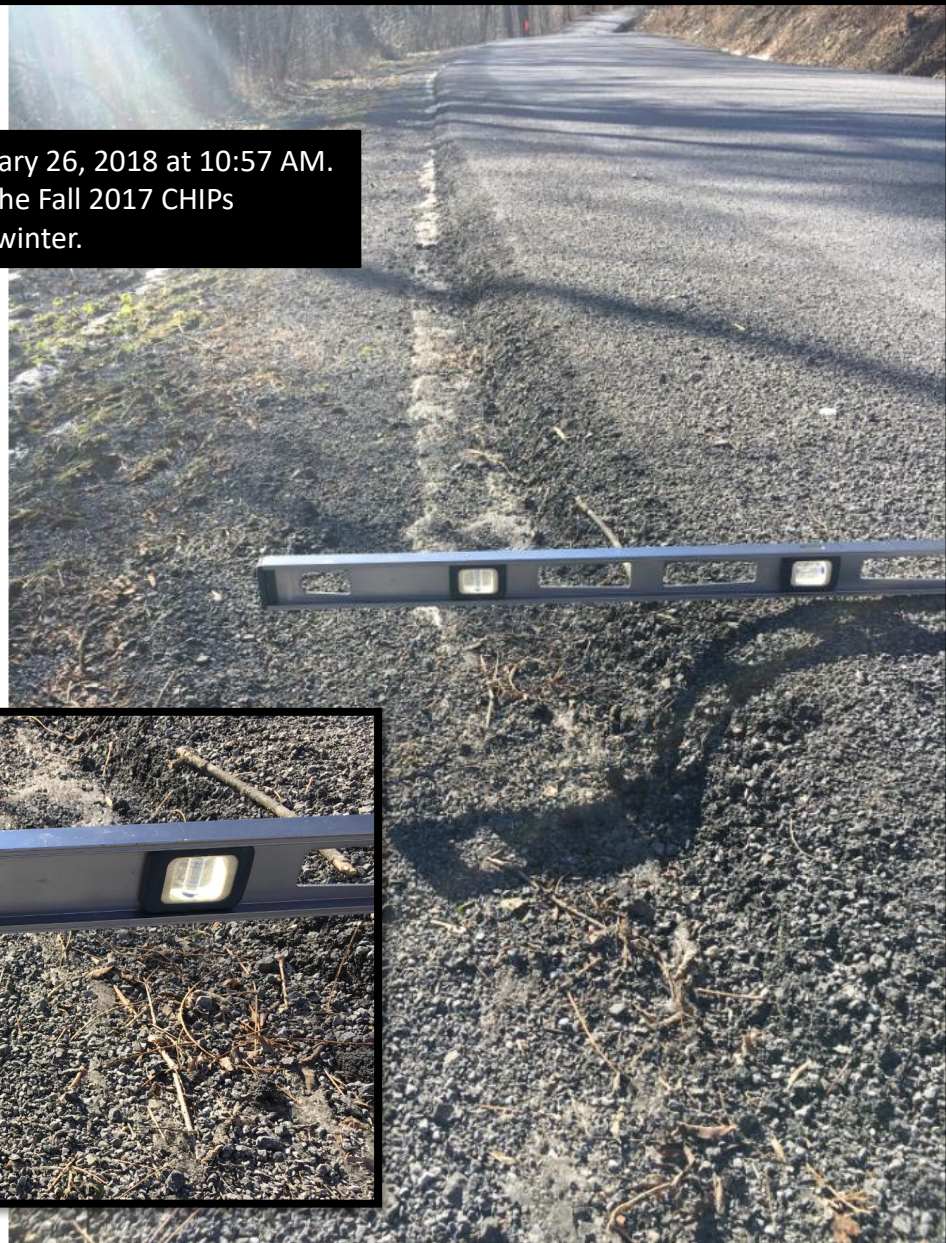
PRACTICE OF LONG-TERM UNPROTECTED DROP OFFS DATES BACK TO 2015

This September 21, 2015 photo at 3:13 PM is from the 2015 Stage Road (west) project. This one lift overlay was placed in summer 2015 and the excessive, unprotected drop-offs were left long term. There is an issue with the administration and coordination of construction operations in Berne. Clearly, if a dangerous condition must remain in place long term to accommodate a proposed operation, a different option must be considered for that operation (shoulder placement). This photo provides historical context. Here on September 21st 2015 unprotected, excessive drop-offs were left long term with the knowledge that a large event (wedding) was taking place there weeks in advance. The practice of just leaving high, unprotected drop-offs is acknowledged in the **2015** clipping by the Superintendent of Highways. There certainly appears to be a conscious decision to continue this dangerous practice through 2020. An Engineer's recommendation regarding how Work Zone Traffic control would be theoretically set up for the subject overlay projects would be very instructive to the Highway Department.

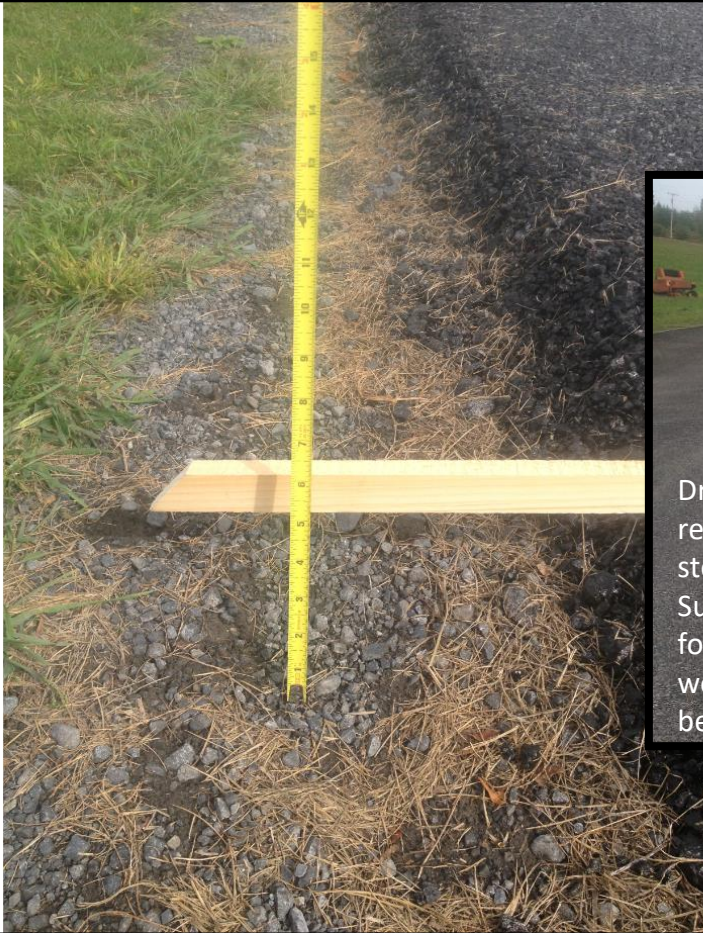
Drop-offs unprotected in 2015

Driveway provided for wedding parking by resident. 150 guests had to negotiate 5 to 8 inch steps at the edges of travel lanes. The Superintendent ignored requests to address this for weeks prior to the event. Parking and walking would not have been an issue if shoulders had been provided.

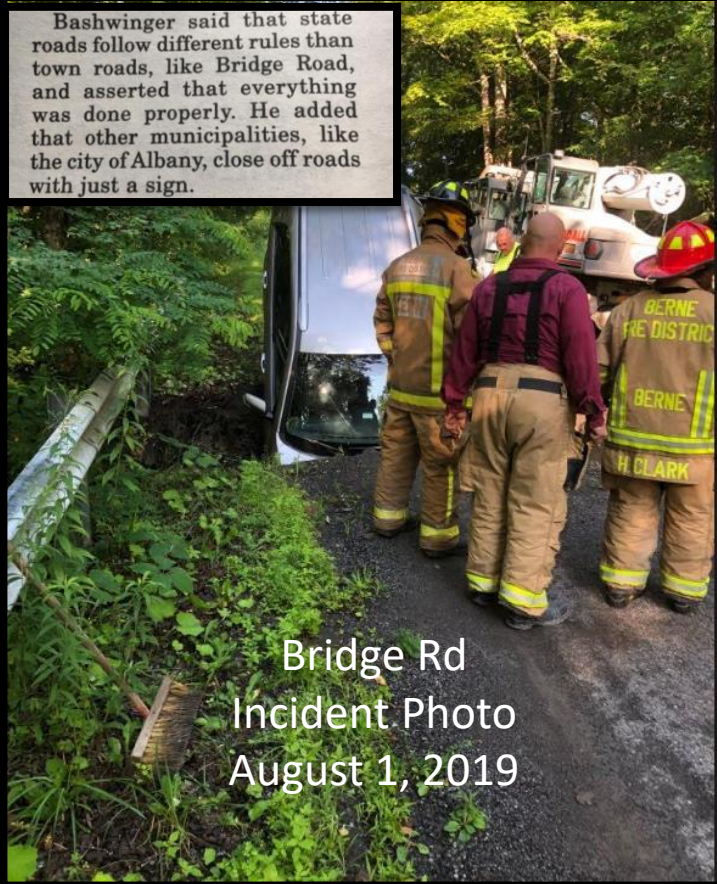
It appears that MUTCD work zone standards for road closure, adopted by NY Vehicle and Traffic Law 1680, are ignored by the Berne Highway Superintendent

Note here that the work site is well beyond the residence with no signs or barricades there – this is how the Bridge road incident happened. The highway was simply **NOT** closed at the worksite

Type III barricades with R11-2 “ROAD CLOSED” signs are light weight plastic tube with aluminum sign panels and could be easily moved and put back in place by the machine operator at the work site to allow the dump truck to come and go while keeping the road closed at the actual point of closure. This needs to be made clear to the Highway Department and would have been addressed in the Engineer’s evaluation.
