*RUSS REEVES, CEng., P.E. CIVIL-STRUCTURAL ENGINEERS NYS Lic. # 063979

July 27, 2022

Re: Emergency Structural Condition Assessment Central Warehouse Building 143 Montgomery Street, Albany, New York.

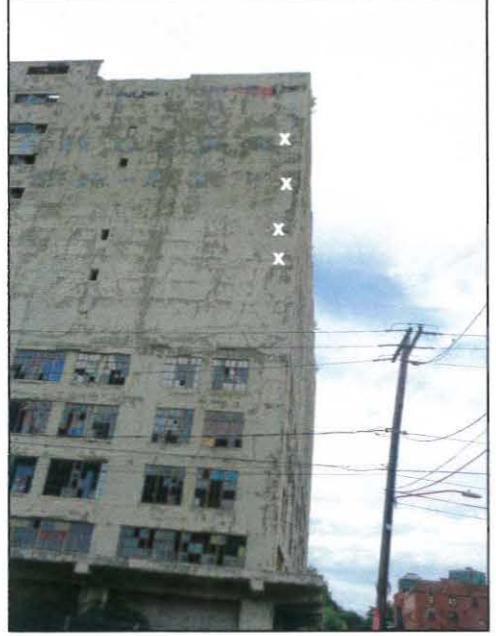
Photograph 4 (Northeasterly Corner)

Photograph 3 shows a typical view along the Northwesterly portion of the building at the 4th and 5th floor level. In this instance, there are spalled masonry spandrel beams that exhibit gross deterioration with portions of the concrete on the verge of failure. This can be more specifically seen in Photograph 3. During the course of the evaluation, we found substantial fracture cracking through the upper Northeasterly corner pilaster. Over the years, water has saturated existing fractures and fissures within the concrete wall section and has frozen and expanded thus dislocating sections of concrete from reinforcing steel and has degraded the concrete to the point where some of the concrete has ruptured thus creating a major public safety hazard. This condition is typical at all four corners of the building.

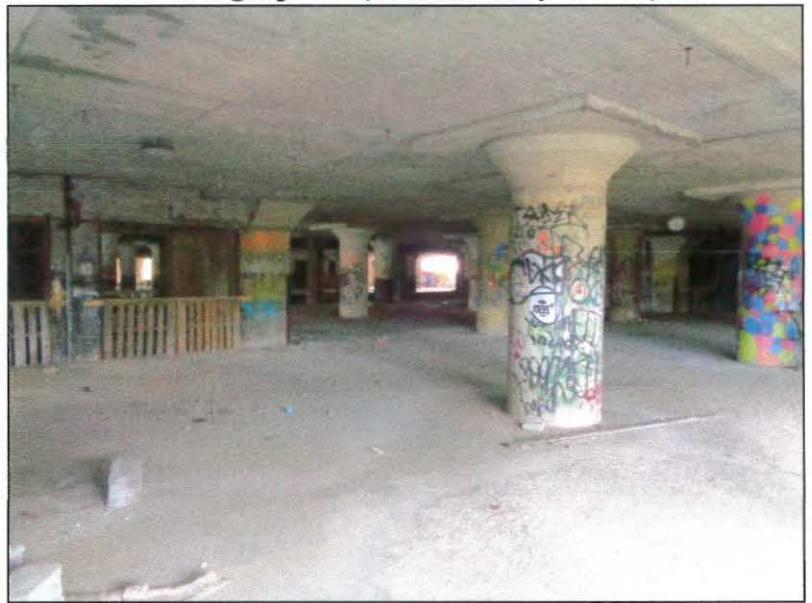
Photograph 12 shows a typical view of the 4' diameter reinforced concrete columns with the flaired capitals and drop panel sections that have been provided so as to distribute column point loads thus avoiding the aforementioned punching shear through the slab. The railroad spur entrance located at the second floor level can be seen in the background of Photograph 12. The train gallery is located at this second floor level. It shall be noted that there is no fall protection to prevent personnel from accidently falling or tripping into the track area which is approximately 4' below the top of slab elevation. The owner shall install a protective barricade as soon as practical.

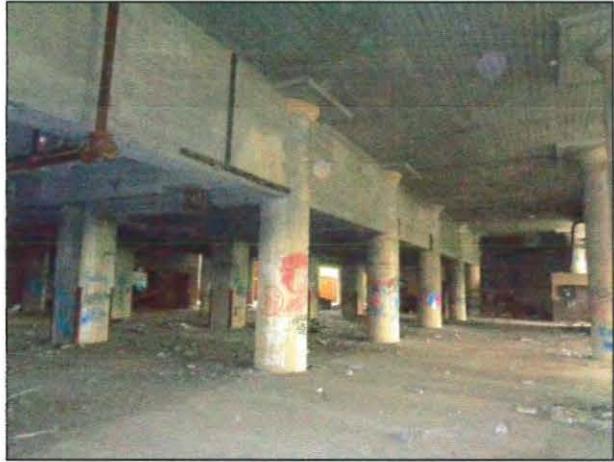
Photograph 15 shows reinforced concrete -deep beam sections with reinforced concrete column supports that are situated at the first floor level and support the locomotive gallery that is located directly above this area on the second floor level. This is provided for informational purposes and for context when entering the first floor level of the building.

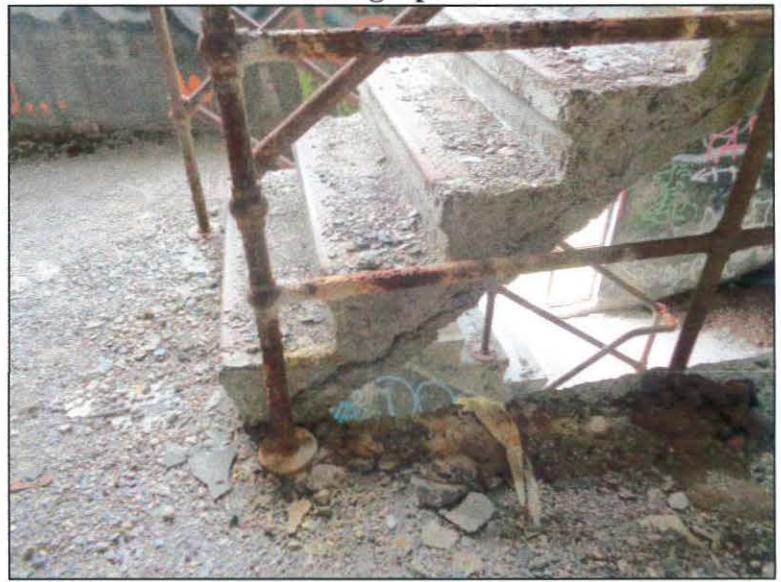
Fracture cracking through various wall sections in the Westerly stair tower can be seen in the upper floor levels. Extreme caution shall be exercised when accessing the upper level staircases due to the extent of fracture cracks and deterioration that have been encountered in the staircase assemblies and the reinforced concrete support beams.

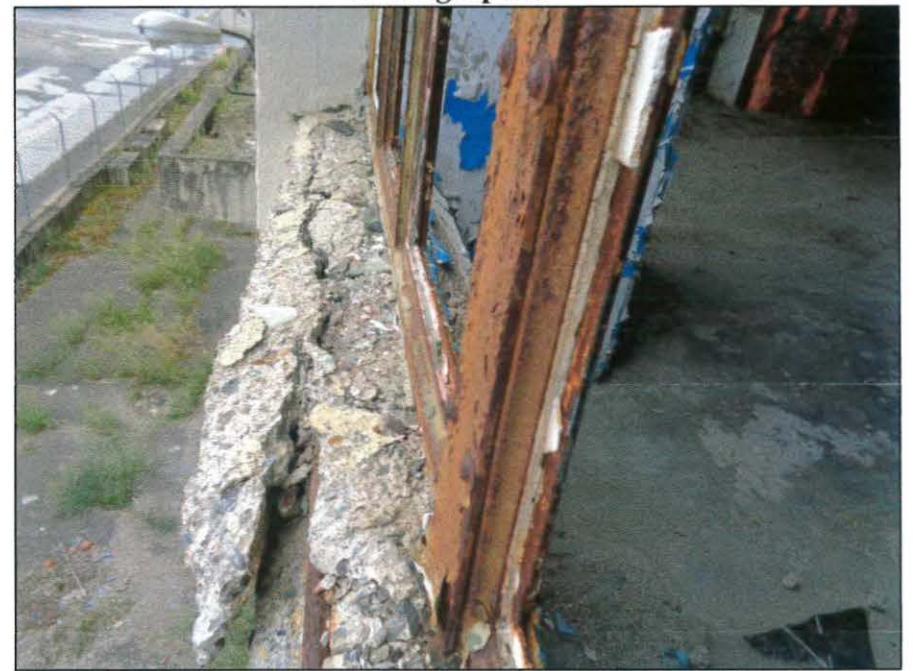
Photograph 20 shows a typical area of spalling and deterioration of the concrete spandrel beams along the Northerly side of the building. A collapse of the top portions of the spandrel beams at these locations are considered imminent at this time.

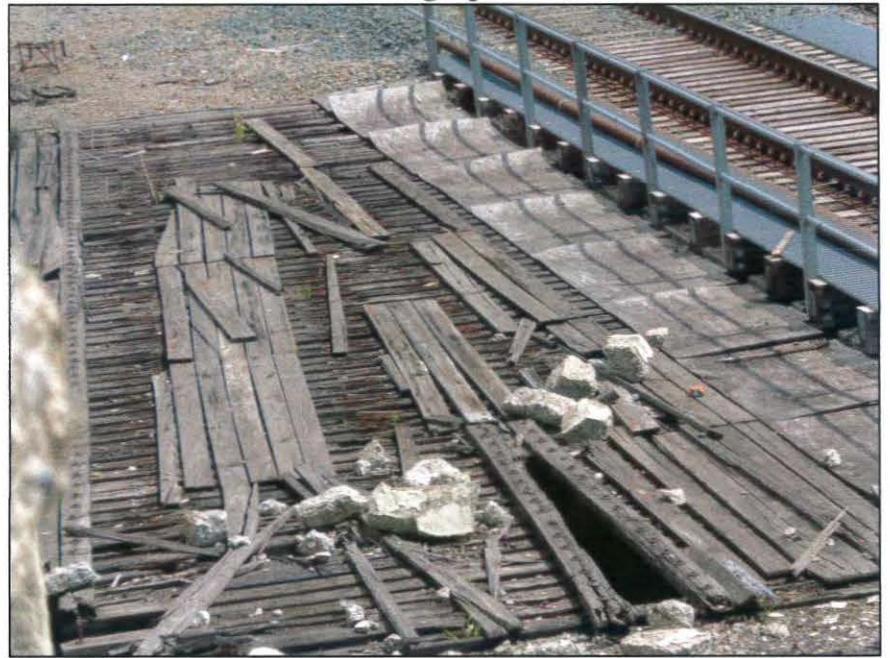
Photograph 24 shows remains of concrete debris that had fallen adjacent to the tracks when the Southeasterly corner section of the building had previously collapsed (refer to Photograph 6 above).

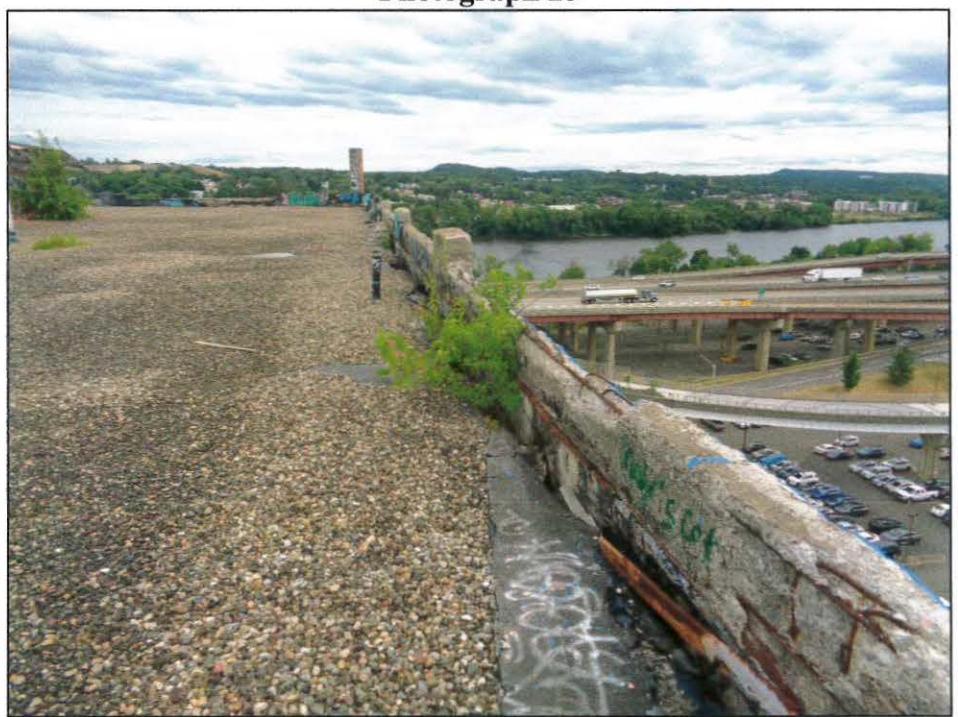
Photograph 25 shows the upper spandrel beam and a portion of the exterior wall section deflecting outward and on the verge of collapse. The issue of the deteriorated exterior masonry concrete will need to be addressed as soon as practicable due to its implication to public safety and the integrity of the Amtrak system along the Southerly side of the building. It is recommended that the Southerly exterior fascia wall be anchored into the interior reinforced

floor system at every floor level using ³/₄" diameter A-304 stainless steel threaded rod and 12" x 12" x 1/4" A-36 steel plates that will restrain the exterior fascia wall. The stainless steel threaded rods shall extend through the fascia wall, through the interior cavity and through the interior wall section and be connected to a ³/₄" x 2" diameter Crosby Eyelet. A 7/16" diameter 6 x 19 class IWRC (Independent Wire Rope Core) cable with turn buckle shall be anchored into the reinforced concrete floor using a WT section with four 5/8" diameter A-304 stainless steel threaded rods having a 4" embedment into the existing concrete slab and epoxy grouted with Hilti Epoxy hit-re 500 V-3. The spacing and location of each wall anchorage will be established as part of the final design for the exterior wall stabilization. Please note that all cable connections will be made with three A-304 stainless steel cable clamps per connection. All steel plate shall be shop painted using DTM Alkyd Enamel paint. Once the exterior wall has been stabilized and anchored into the floor system at every floor level, braced scaffolding can be erected that will afford the safe removal of the deteriorated and failing reinforced concrete spandrel beams. Deteriorated and failing steel window frames shall also be carefully removed so they do not collapse in this removal and stabilization process. The braced scaffolding will need to be laterally restrained into competent concrete at each floor level with the existing concrete floor slab being the primary means of restraint. The owner's engineer shall provide the necessary stabilization drawings, procedures and material specifications to the City of Albany for review and approval.

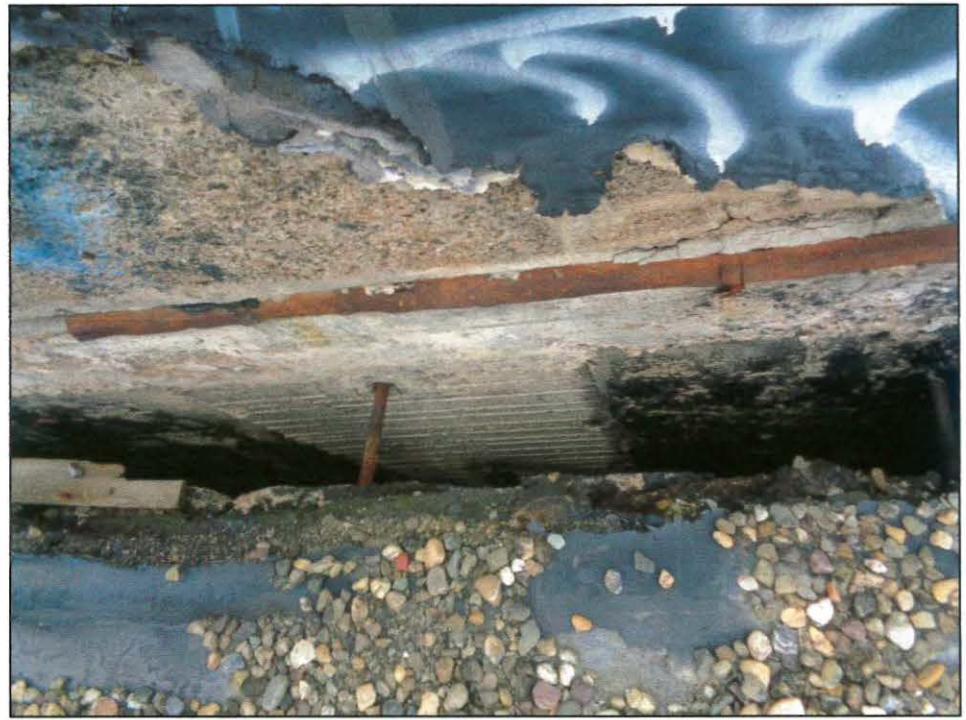
Photograph 27

Lastly we accessed the roof area in which we found substantial deterioration and failure in the perimeter parapet wall and failure at the interface of the roof slab and the exterior fascial wall. Photograph 26 shows deterioration and failure at the Southerly parapet wall. This parapet wall is highly unstable. Movement in the parapet wall was detected while on- site. Heavy vibration and movement of the wall was noted especially when Amtrak trains passed the building. Photographs 27 and 28 show a typical view of the failed section of roof and deteriorated tie rods that connect the exterior wall section with the interior wall section. Photograph 29 shows the
